BARWON SEWER AQUEDUCT

Report by

Independent
Panel of
Inquiry

May 1996

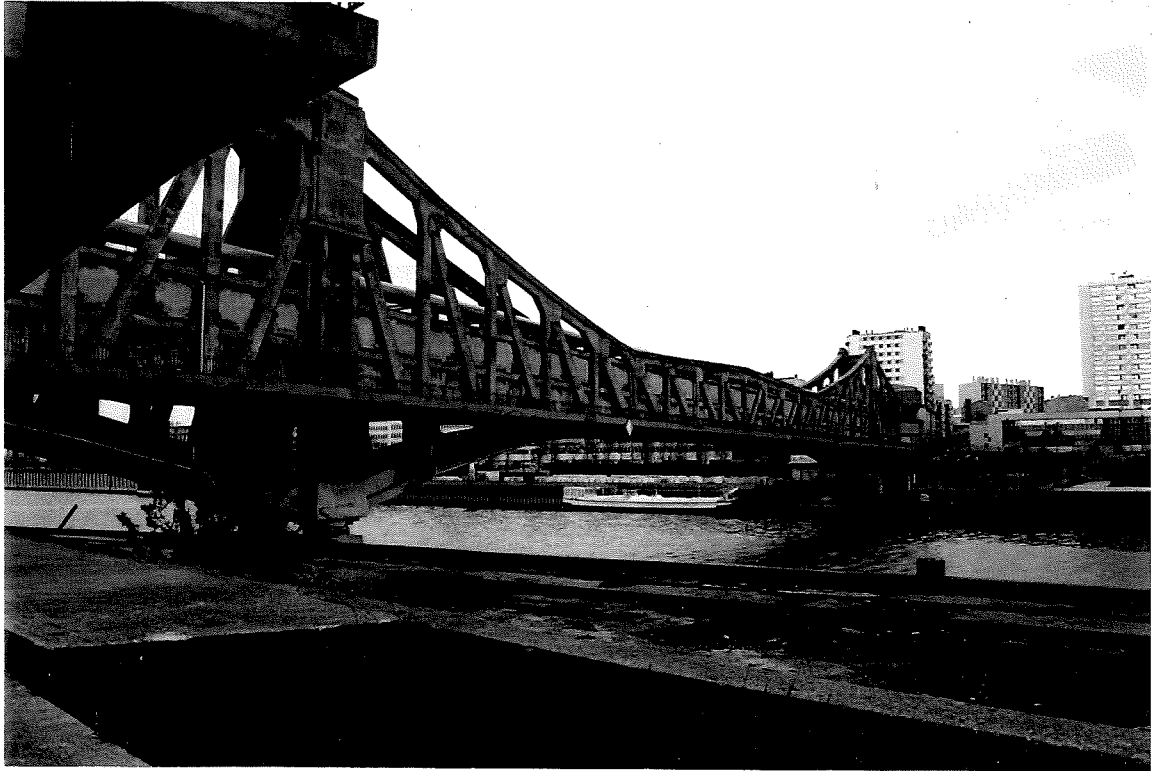
PHOTO 4 PONT D'IVRY SUR SEINE

I cannot agree with Professor Baker's comment that the Ivory Bridge is of no relevance to the Aqueduct. It is clearly a bridge of similar age and engineering design. Advice is that this structure is in a good state of repair. There would seem to be opportunities to learn from the management techniques used on that bridge. Contact was made with Parisian authorities responsible for the Ivory bridge as part of this enquiry. A reply was received to our written correspondence only on 17th May.
