# Upper Barwon River Investigation Spring 2020

- Data Report
- February 2021

| <b>Name of project:</b> | Barwon River/ Boundary Creek Survey |

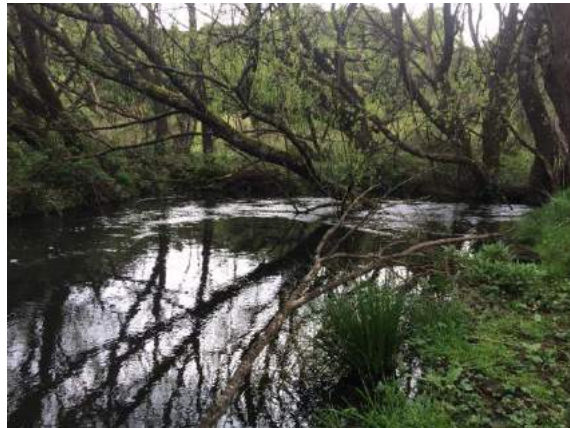
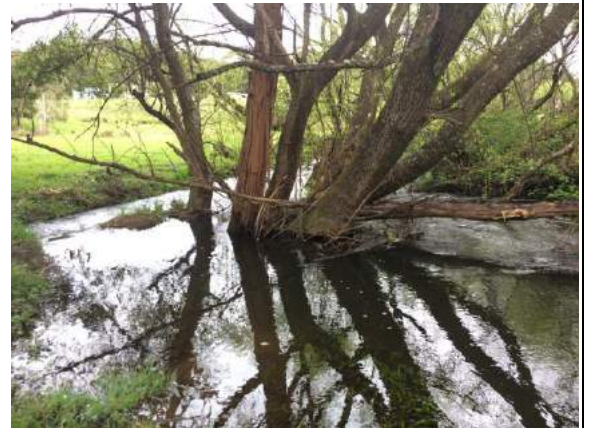
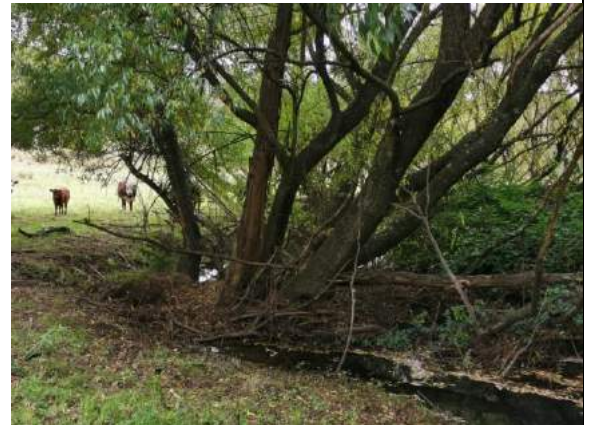
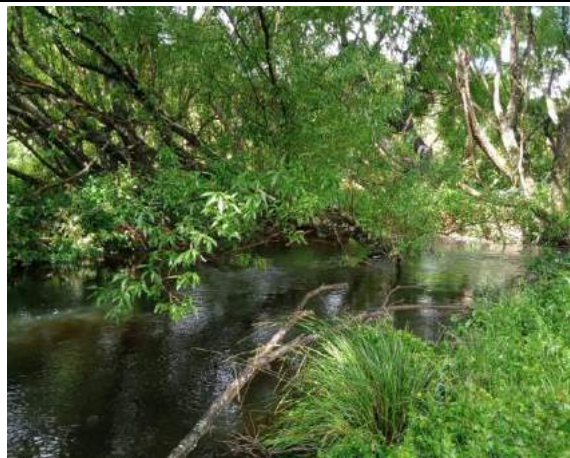
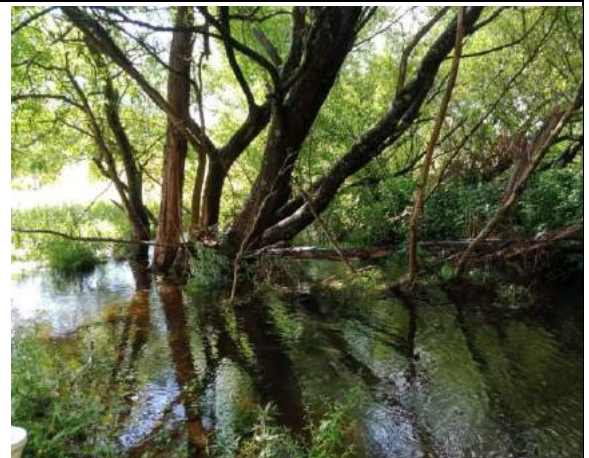
The East Barwon at Kents Road has diverse habitat with large deep pools and some riffle/run areas although in Autumn these runs had dried to trickles. The average stream width at was eight meters and bank full in Spring but had contracted to five meters in Autumn. Willows dominate the riparian zone and are growing within the stream channel. The

substrate is a mix of clay and silt with a number of aquatic macrophytes growing in the margins and shallow pool areas. The majority of the riparian zone is exotic vegetation, dominated by blackberries, willows and pasture grass. One larval fish was collected as bycatch during macroinvertebrate sampling. A concurrent snapshot study by EnviroDNA (2019) found evidence of platypus at this site. Overall analysis of the health of the waterway using EPA habitat parameters for Low Gradient Streams gives this site a score of 74 out of 140.

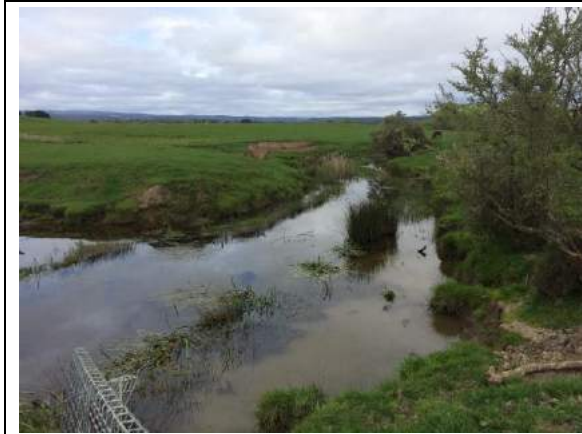
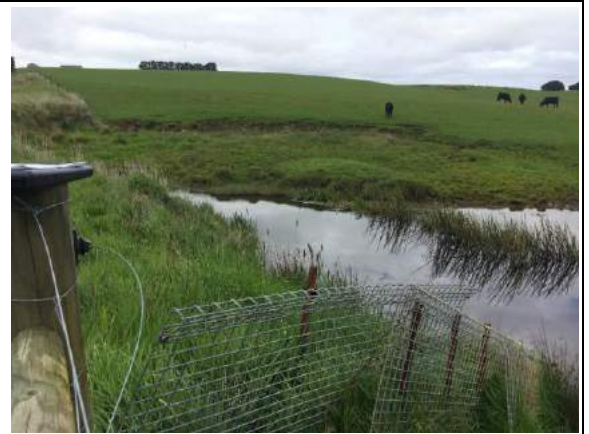
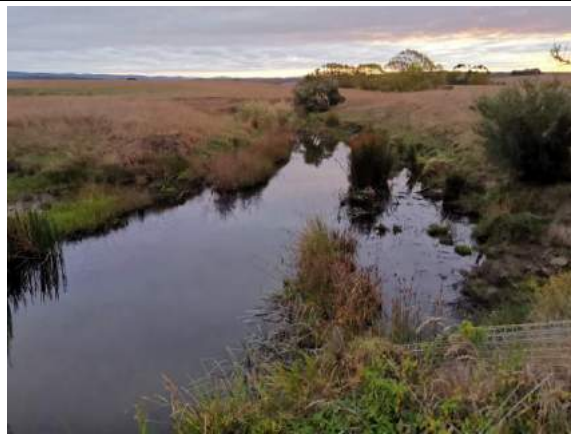
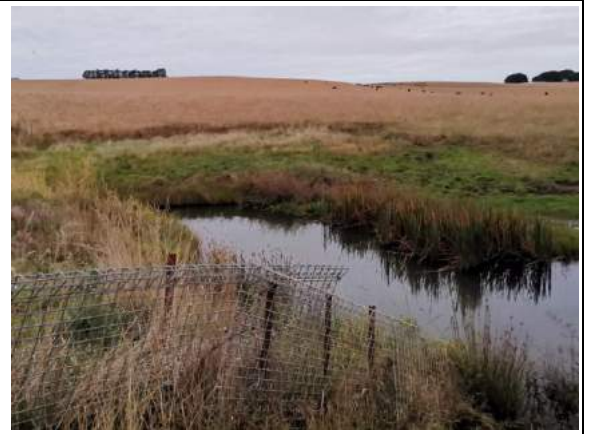
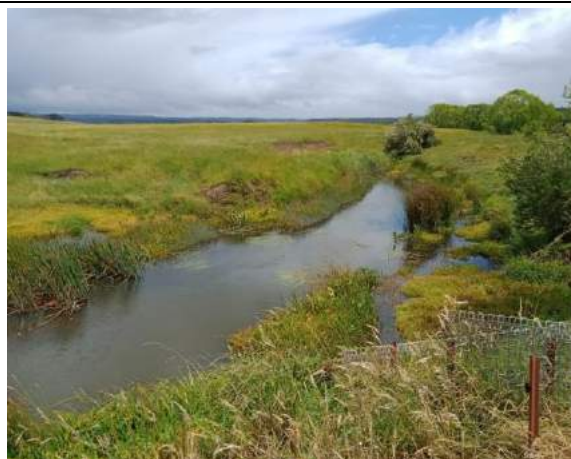
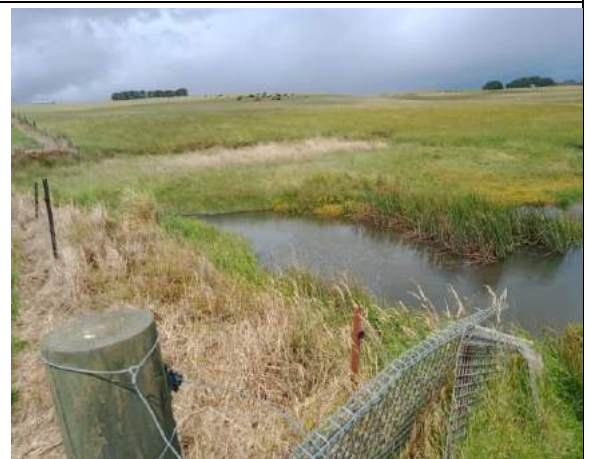
The East Barwon at Dewings Bridge Road consists of a slow flowing channel with extensive backwaters. There is very little riparian zone present but a number of submerged and emergent macrophytes provide good habitat for macroinvertebrates and fish. One larval fish was found in the sample net in Autumn 2020 and three pygmy perch in Spring 2020. The substrate is a mix of clay and silt with some sand. The average stream width at this site was seven meters and was bank full during both Spring and Autumn sampling. The majority of the riparian zone is pasture grass with stock access on both sides. Overall analysis of the

health of the waterway using EPA habitat parameters for Low Gradient Streams gives this site a score of 59 out of 140.

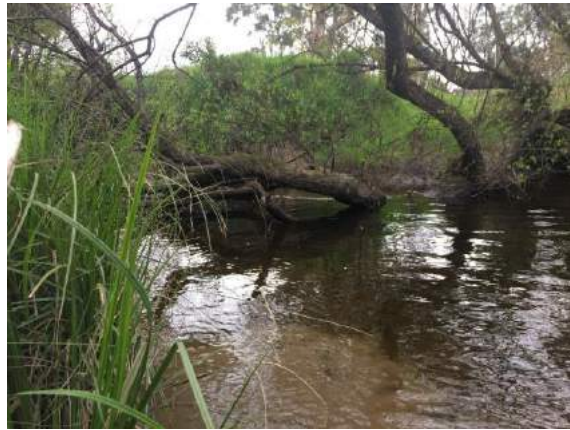
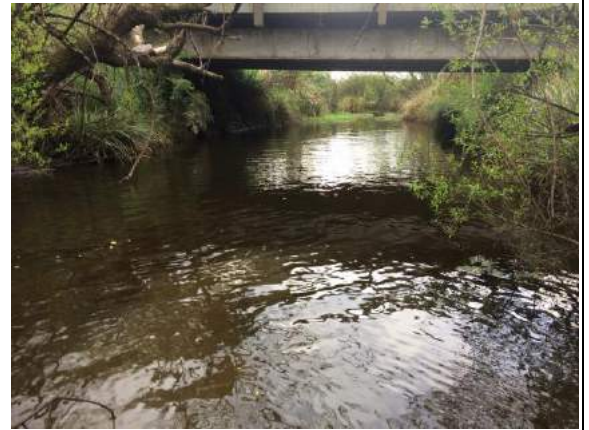
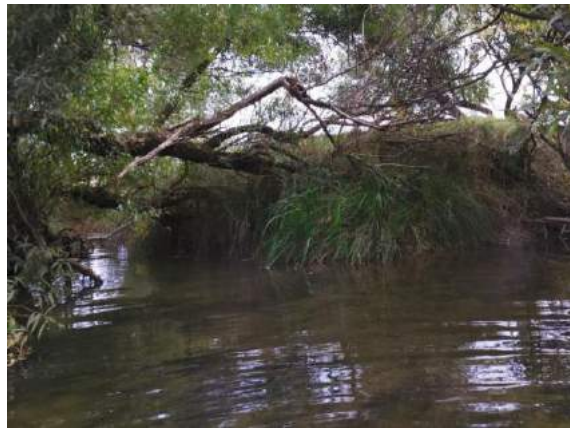
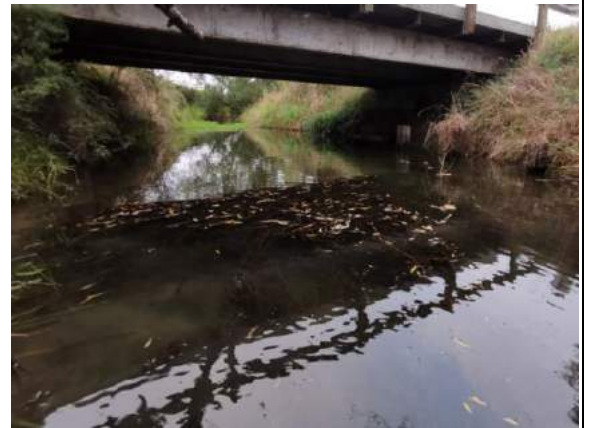
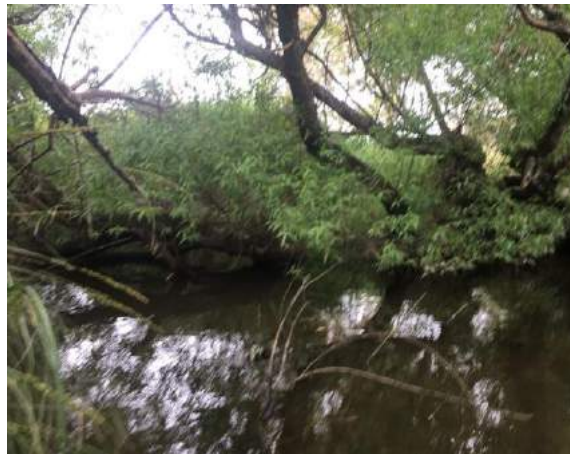
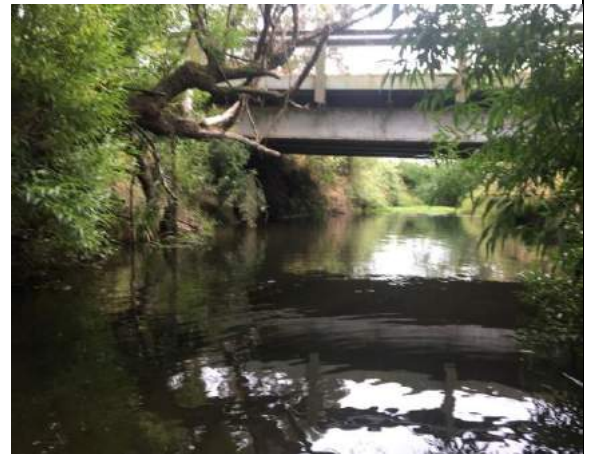
The West Barwon River at Seven Bridges Road has large deep pools with a number of large deep backwaters. The average stream width at this site is seven meters, narrow at the top of the surveyed reach and widening into a large pool near the bridge. The substrate is clay and silt mixed with 20% sand. There are some macrophytes present along with trailing bank vegetation, roots and instream large woody debris (primarily willow branches). Willows dominate the riparian zone a mix of shrubs and native and pasture grasses in the understory. Four larval fish were collected as bycatch during macroinvertebrate sampling in

Spring 2019. One mountain galaxias, one common galaxias, one pygmy perch and a laval galaxias were collected in Spring 2020. A concurrent snapshot study by EnviroDNA (2019) found evidence of platypus at this site in Spring 2019. Overall analysis of the health of the waterway using EPA habitat parameters for Low Gradient Streams gives this site a score of 85 out of 140.

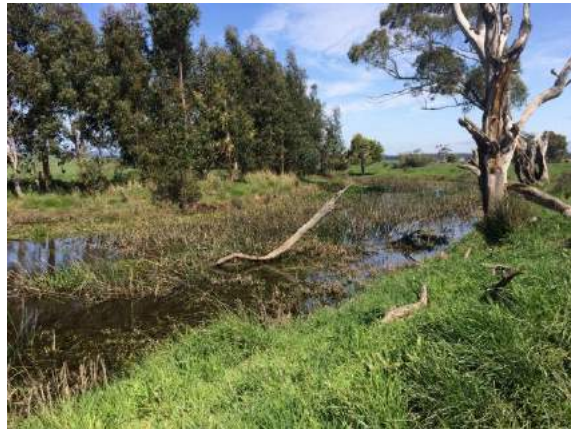
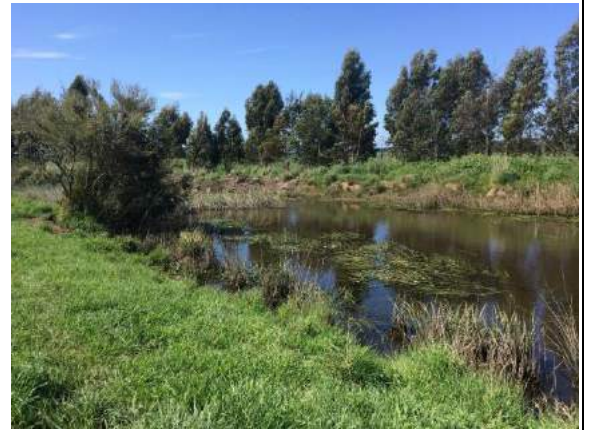
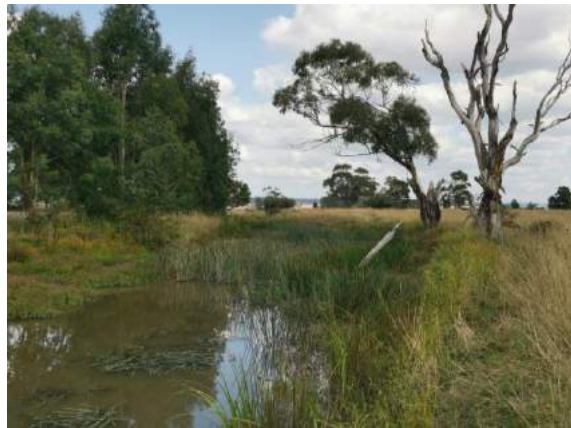
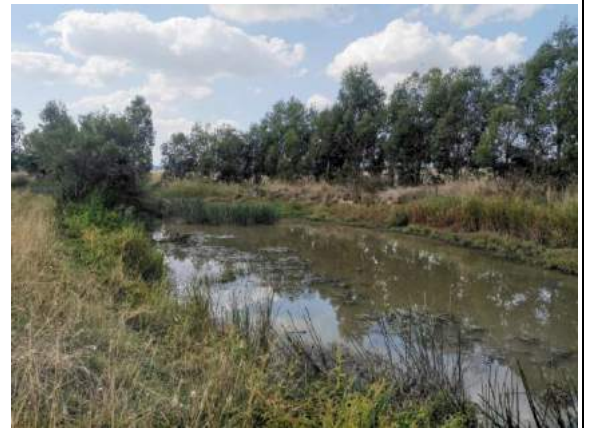
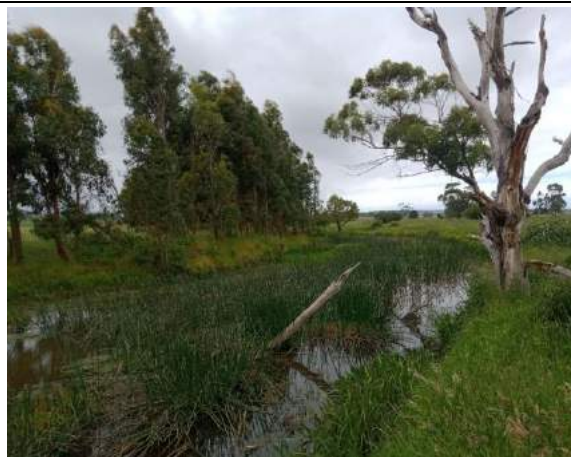
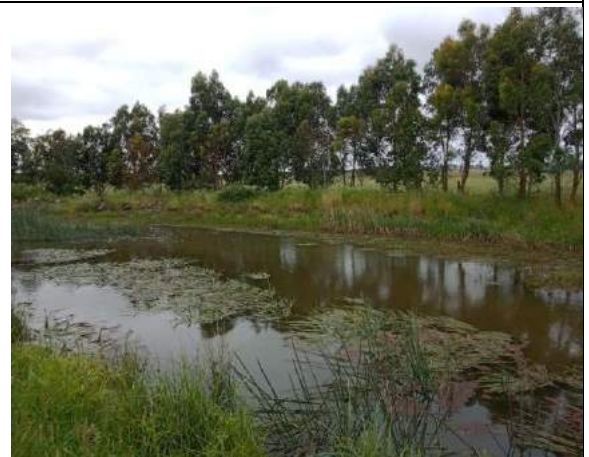
The Barwon River immediately upstream of the Boundary Creek confluence is a large slow flowing channel with shallow side sections that support a number of macrophyte beds. The average stream width at this site is nine meters. The substrate is clay and black silt with some large woody debris and filamentous algae present in addition to the macrophytes. *Juncus*, *Typha*, *Triglochin* and *Polygonum* are all present instream though riparian vegetation is limited to some isolated trees, a narrow native plantation and pasture grass with stock access. The introduced *Gambusia* (mosquito fish) were collected as bycatch

during macroinvertebrate sampling in Spring 2019. Overall analysis of the health of the waterway using EPA habitat parameters for Low Gradient Streams gives this site a score of 79 out of 140.

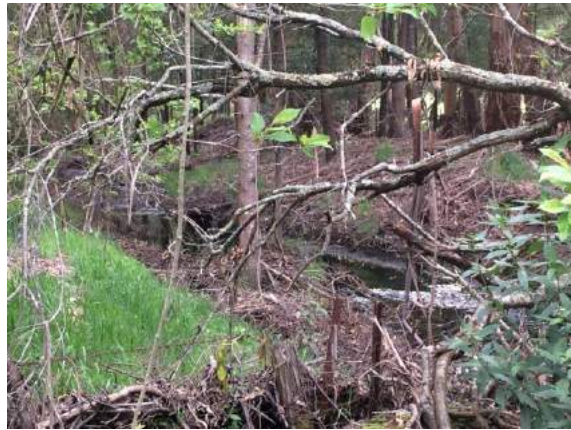
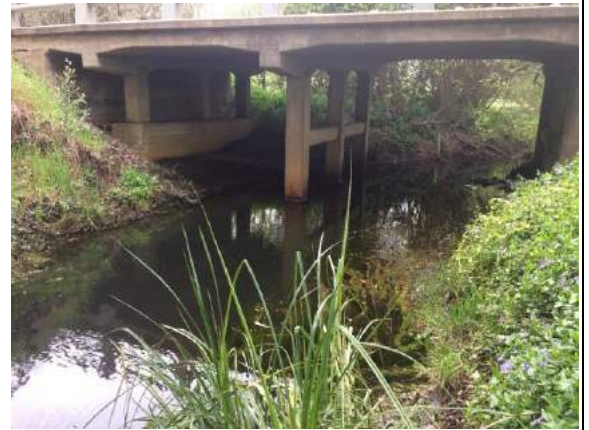
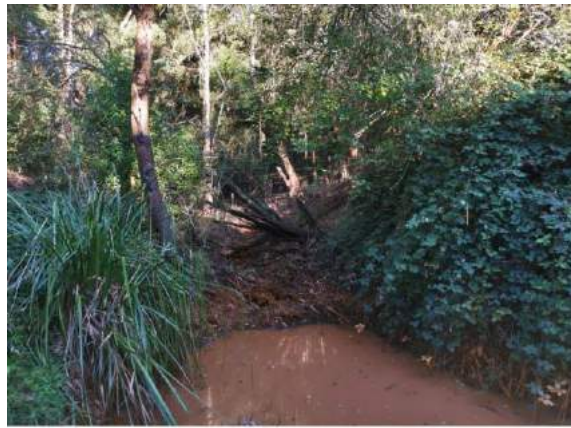
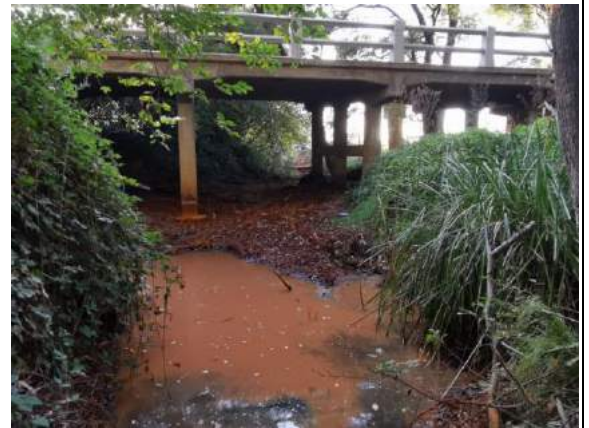
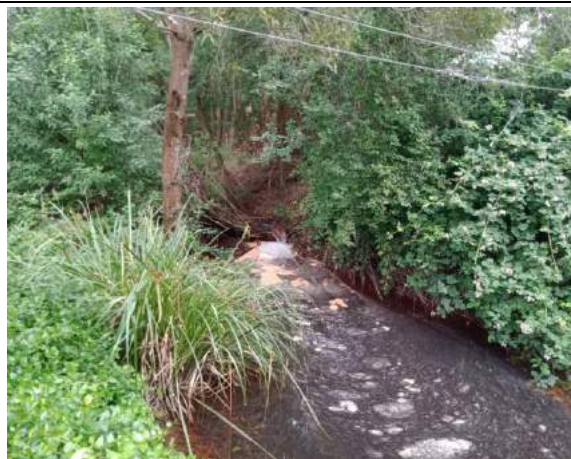
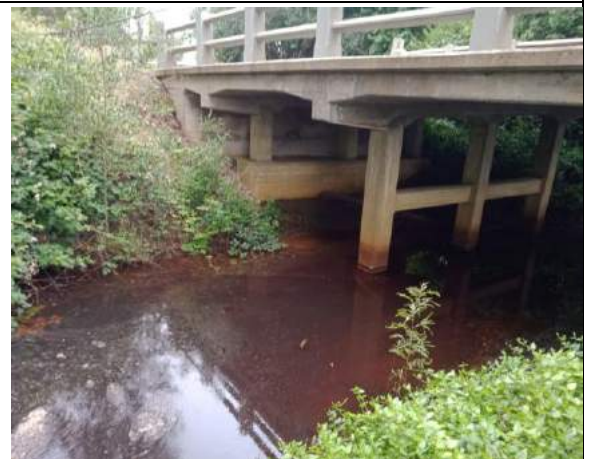
Boundary Creek at Colac- Forrest Road has a mix of large deep pools, a large shallow pool at the bridge and shallow runs. It was bankfull at the time of Spring sampling in 2019 and 2020 with an average stream width of four meters, narrow at the top of the surveyed reach and widening into a large pool upstream of the bridge. During Autumn 2020 sampling, Boundary Creek at this site had contracted to a pool approximately 4 meters long by 2.5 meters wide. The pooled water was stagnant, with low oxygen concentrations and very high turbidity. The substrate is a mix of cobble, pebble, gravel, sand, clay and silt. There are no

macrophytes but there was some filamentous algae in Spring 2019, (absent in Spring 2020) and trailing bank vegetation present. The riparian zone is wide and a mix of native and exotic vegetation except the ground cover which is dominated by *Convolvulus* sp. and pasture grasses. Overall analysis of the health of the waterway using EPA habitat parameters for Low Gradient Streams gives this site a score of 81 out of 140.

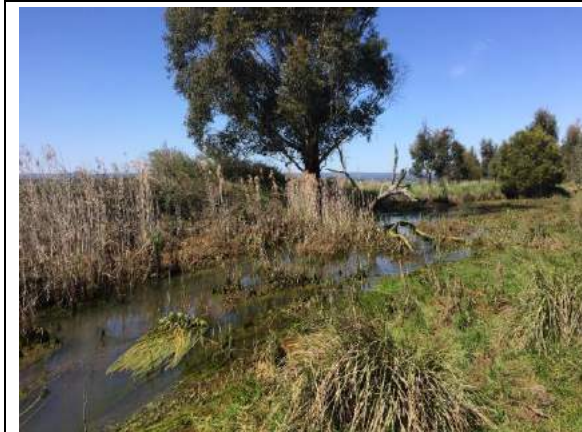
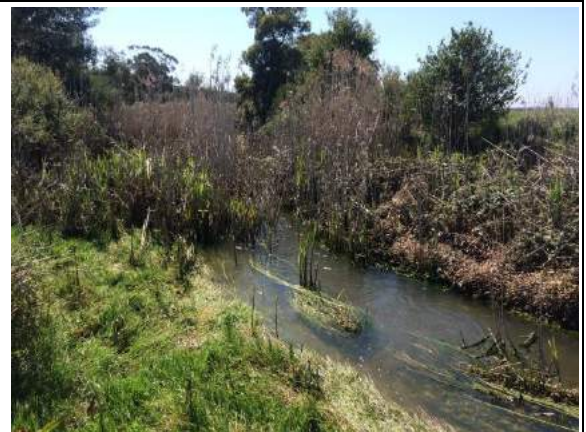
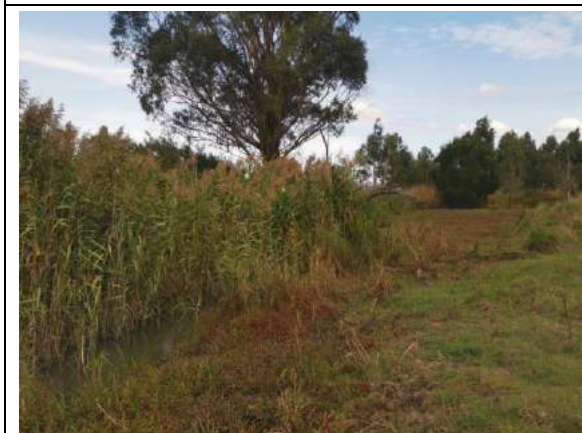
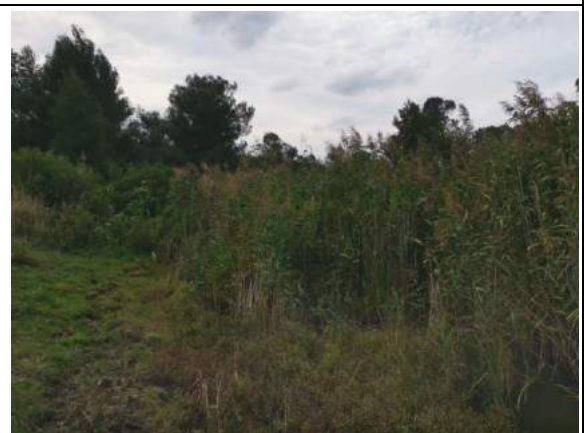
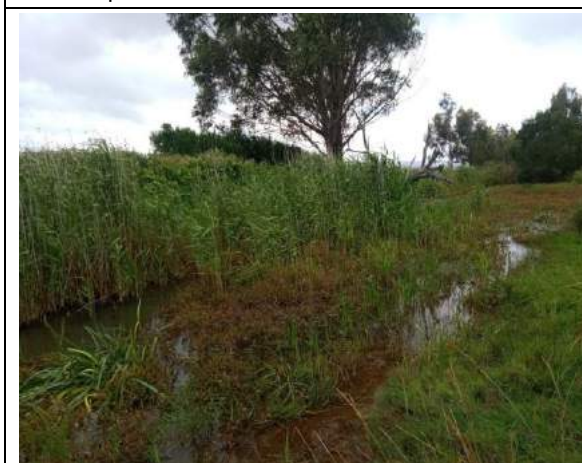
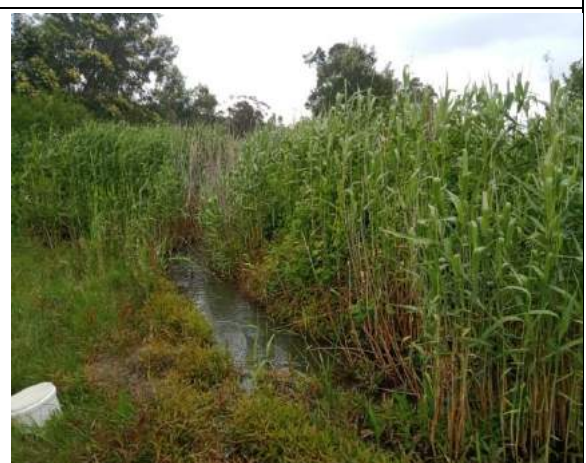
The Barwon River immediately downstream of the Boundary Creek confluence is a narrow deep channel with wide shallow edges dominated by grasses and aquatic macrophytes. The average stream width at this site is five meters and was bank full in Spring 2019 and 2020. There is a narrow channel at the top of the surveyed reach, narrowing to a confined channel downstream. The river had contracted to the main channel but remained flowing, leaving the fringes to dry out in Autumn 2020. The substrate consists of clay and silt with filamentous algae tangled through the macrophyte beds. Macrophyte species are varied

with Triglochin, Polygonum, Phragmites, and Juncus all present in addition to trailing grasses. Three different fish species were collected at this site as bycatch; southern pygmy perch, smelt and a galaxid in Autumn 2020 and gambusia and southern pygmy perch in Spring 2020. The riparian zone is limited to grasses and scattered native trees and shrubs with stock access to the site. Overall analysis of the health of the waterway using EPA habitat parameters for Low Gradient Streams gives this site a score of 70 out of 140.

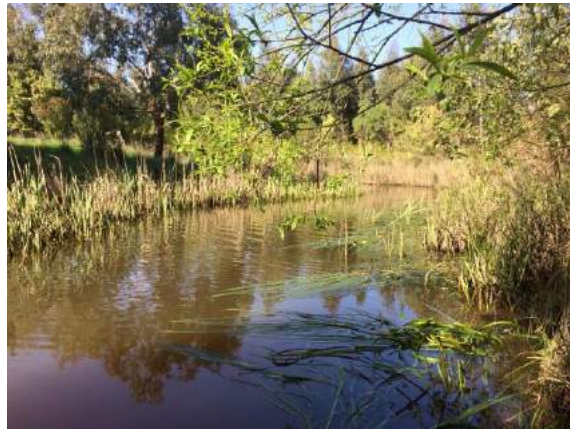
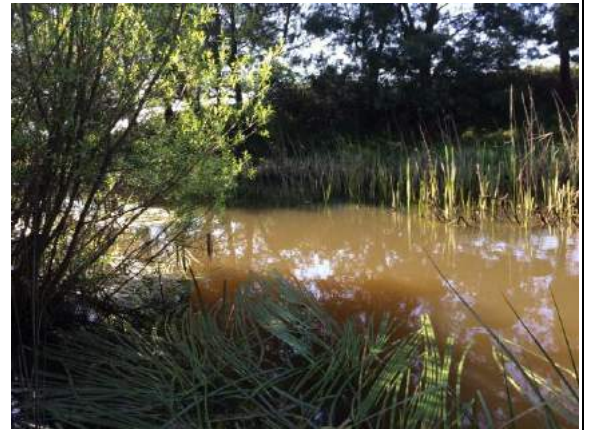
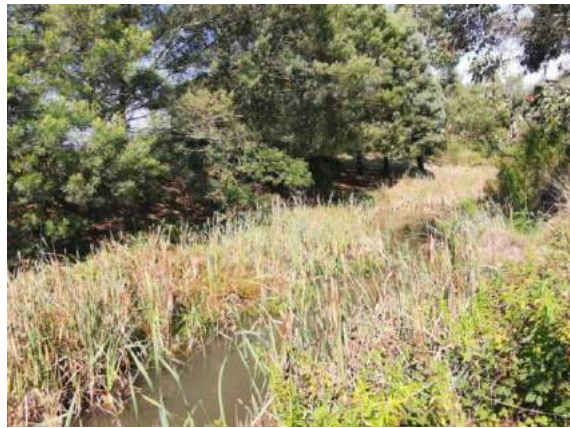
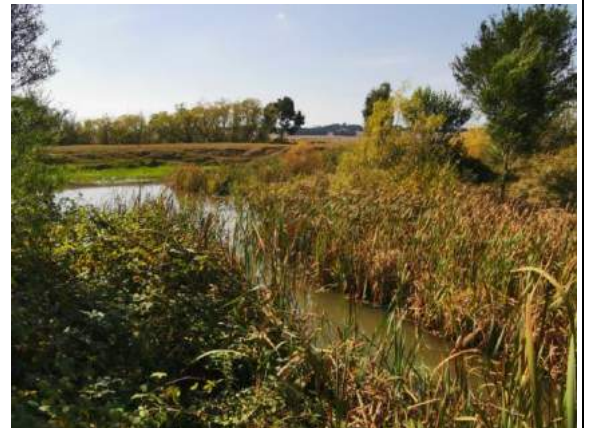
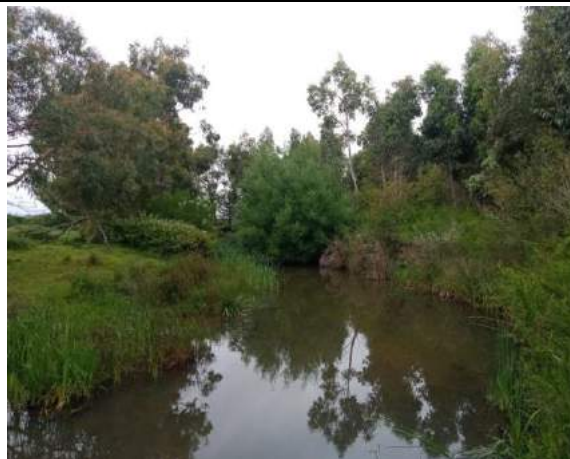
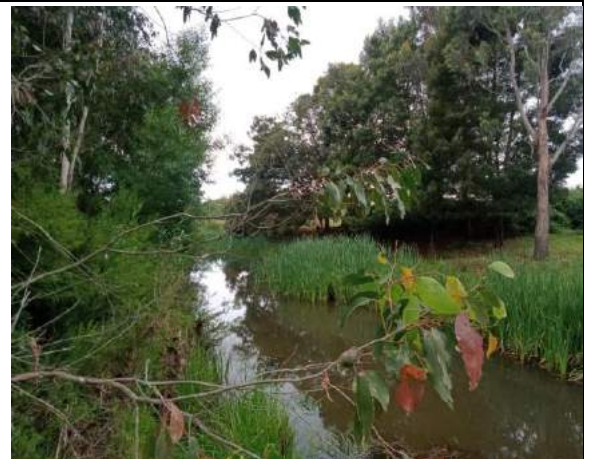
The Barwon River upstream of CO\_BAR16 adjacent to the northern boundary of the pine plantation has a large deep channel with any shallow areas dominated by beds of *Phragmites*. The average stream width at this site is seven meters. The substrate is clay and silt. In addition to the *Phragmites* beds there are beds of *Triglochin*, and scattered *Polygonum*, *Juncus* and other grasses. The riparian zone has a good mix of trees, shrubs and understory with a majority of native trees and shrubs. Overall analysis of the health of

the waterway using EPA habitat parameters for Low Gradient Streams gives this site a score of 90 out of 140.

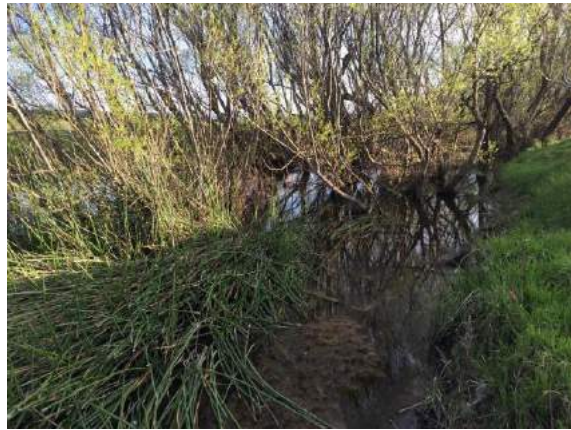
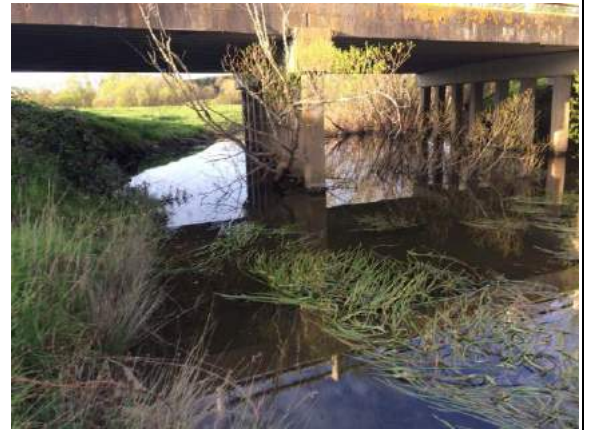
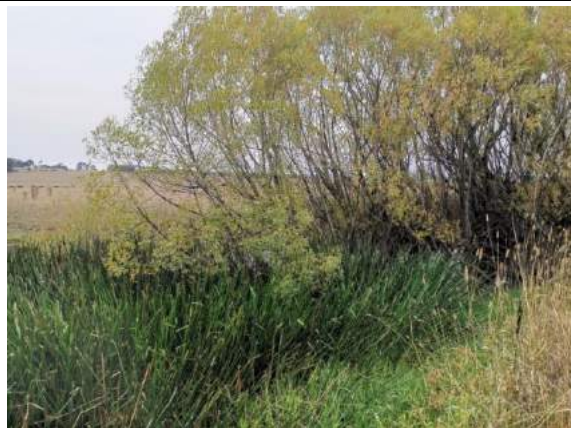
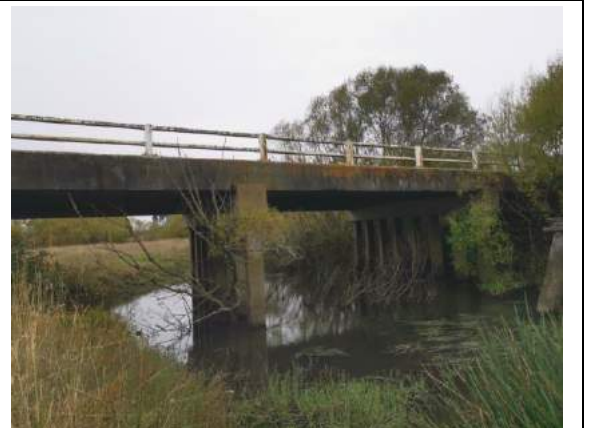
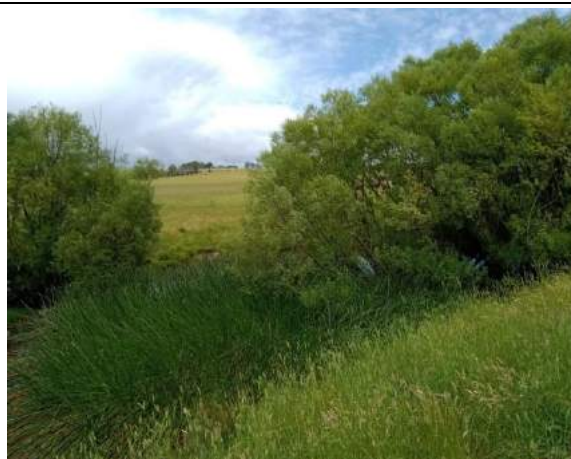
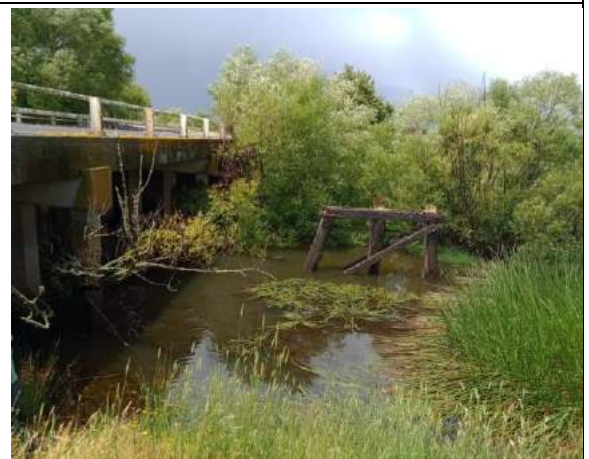
The Barwon River at Colac- Lorne Road has large deep pools with a shallow areas at the sides and willow trees growing in the channel and some substrate exposed. The average stream width at this site is eight meters with a predominantly clay and silt substrate mixed with some sand. There are beds of Triglochin and Phragmites in addition to trailing grasses and large willows. The riparian zone consists of willow trees, pasture grasses and blackberries and allows stock access. Overall analysis of the health of the waterway using EPA habitat parameters for Low Gradient Streams gives this site a score of 69 out of 140.

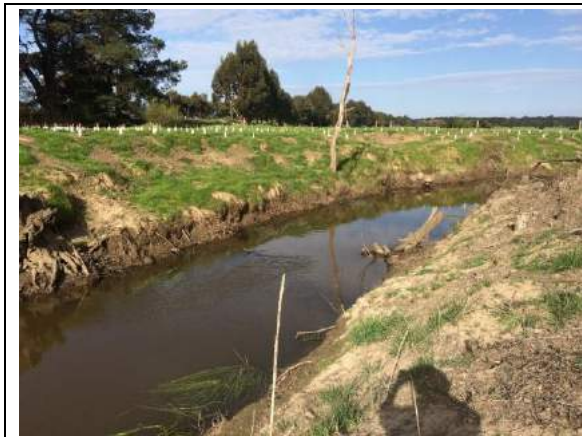
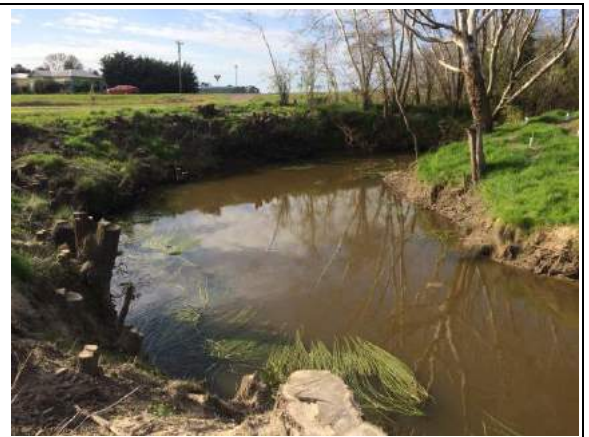
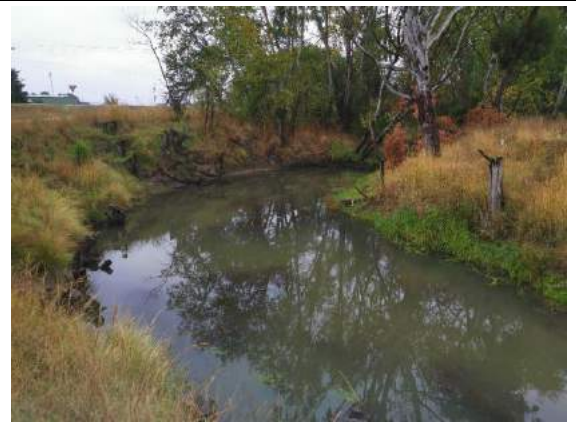
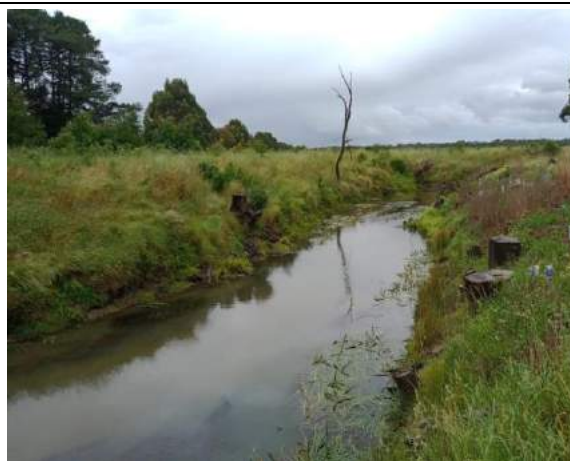
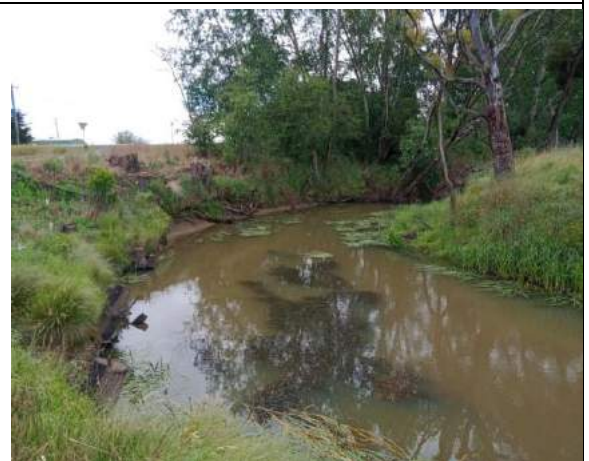
The Barwon River at Birregurra consists of a large deep slow flowing pool. The average stream width at this site is five meters with steep clay banks. The substrate is clay and silt with willow roots, some snags and Triglochin beds scattered along the edges of the channel. There were recent willow removal works and replanting of the riparian zone in Spring 2019 amongst the pasture grass and blackberry groundcover. Rakali footprints were evident in

the soft sediment edge in Spring 2019. Overall analysis of the health of the waterway using EPA habitat parameters for Low Gradient Streams gives this site a score of 67 out of 140.

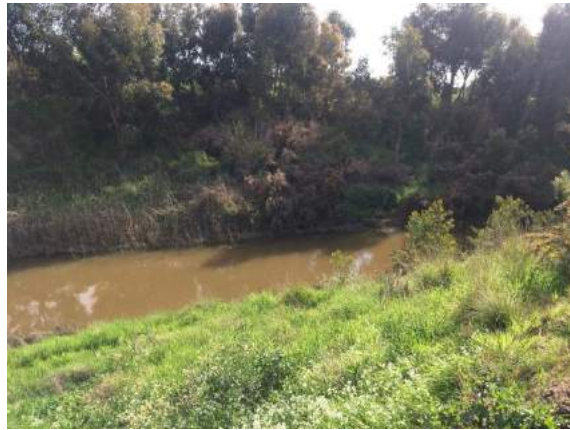
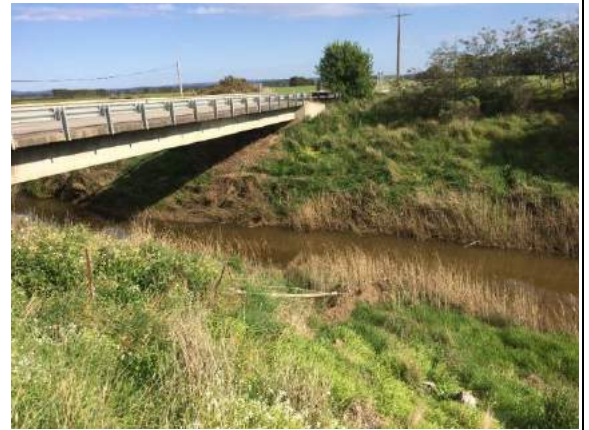
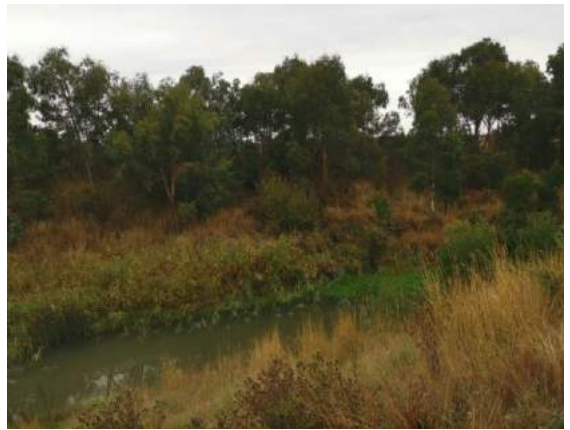
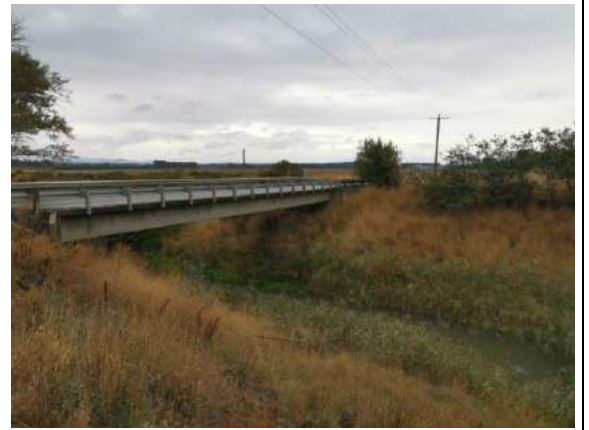
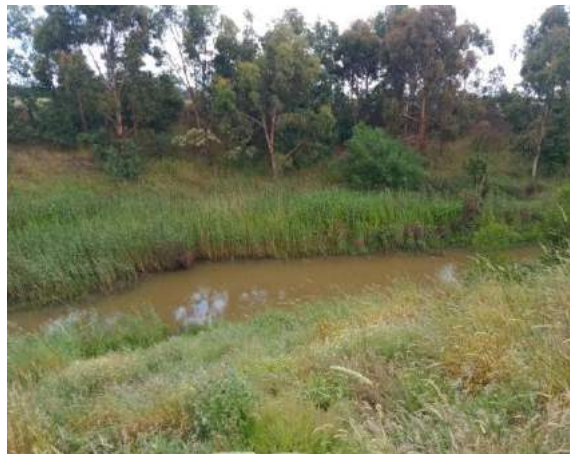
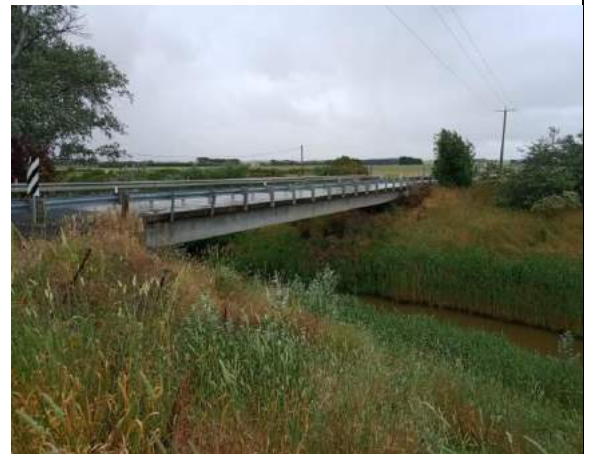
The Barwon River at Conns Lane has large deep pools with some small deep backwaters and a narrow deep run at the top of the reach. The average stream width at this site is six meters. The substrate is clay and silt mixed with some sand and gravel. Phragmites beds line the channel and there are isolated patches of Triglochin in addition to Polygonum and trailing grasses along the waters edge. Larval fish and gambusia were collected in the macroinvertebrate net in Spring 2020. The riparian zone consists of relatively new and older native revegetation with pasture grass understory. Overall analysis of the health of the

waterway using EPA habitat parameters for Low Gradient Streams gives this site a score of 98 out of 140.

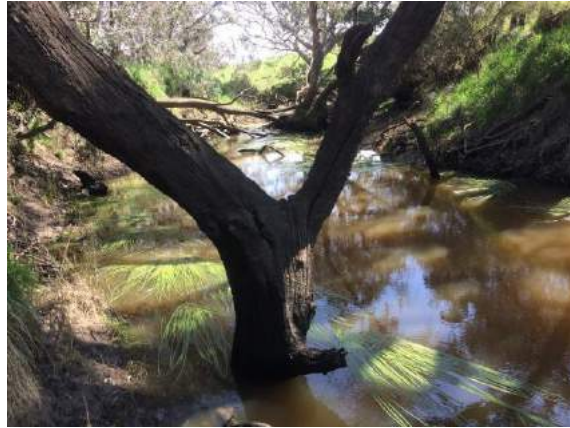
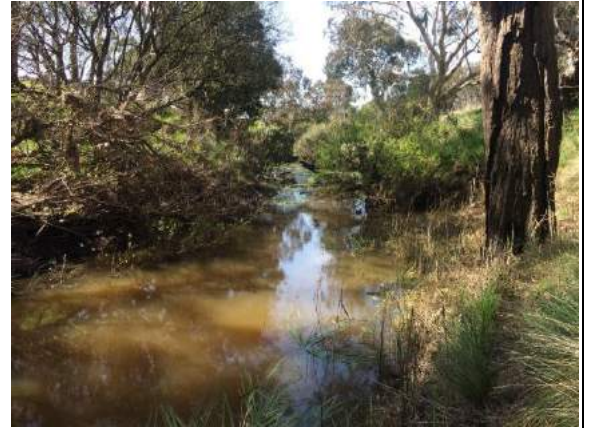
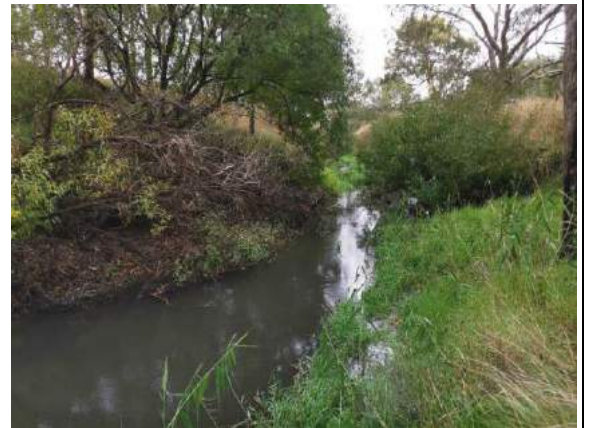
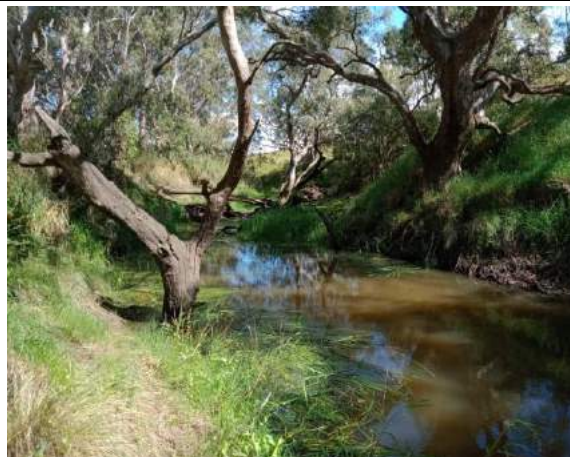
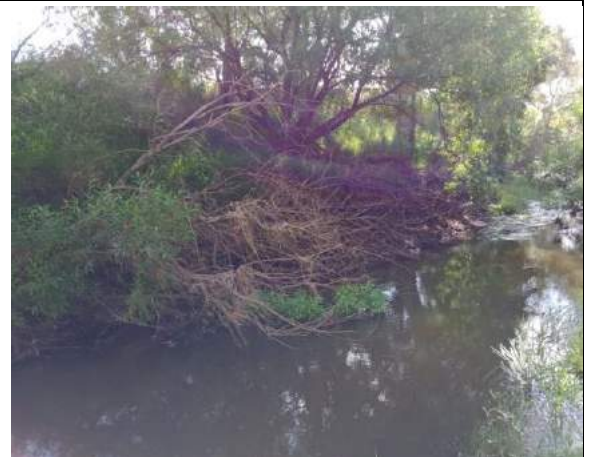
The Barwon River at Winchelsea- Deans Marsh Road has large deep pools with a shallow run at the top of the reach. The average stream width at this site is five meters and the substrate is clay and silt mixed with some sand and gravel. Triglochin is growing in the shallow areas of the channel and there are roots, large woody debris and trailing grasses. The riparian zone is predominately native trees and understory with a mix of grasses as groundcover. Rakali footprints were spotted at the waters edge in Spring 2019. Overall

analysis of the health of the waterway using EPA habitat parameters for Low Gradient Streams gives this site a score of 90 out of 140.

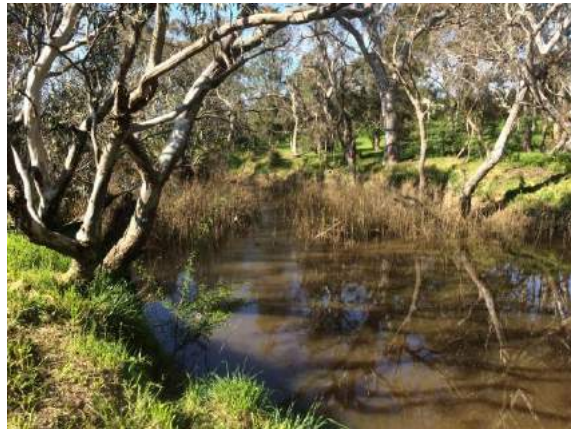
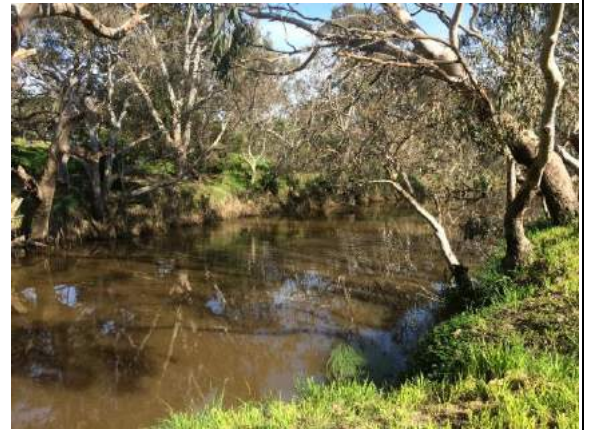
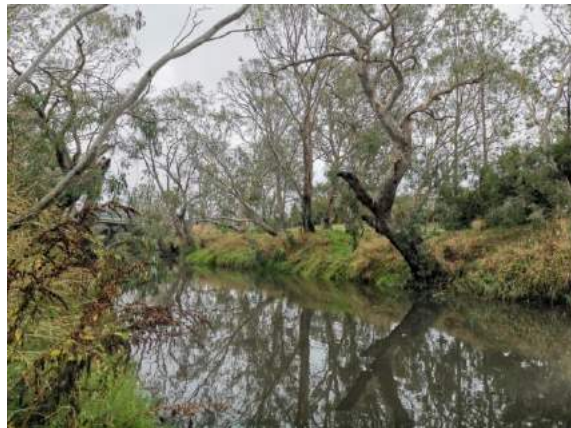
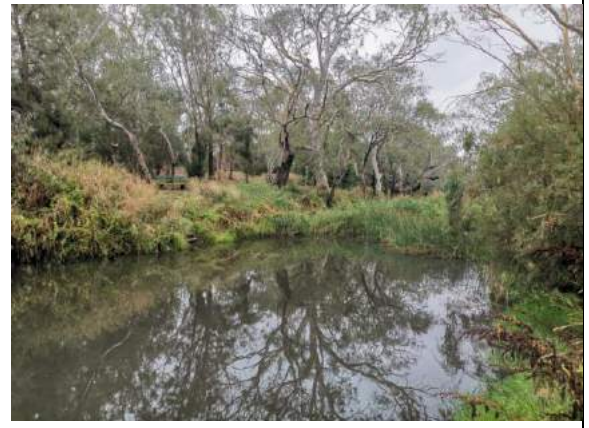
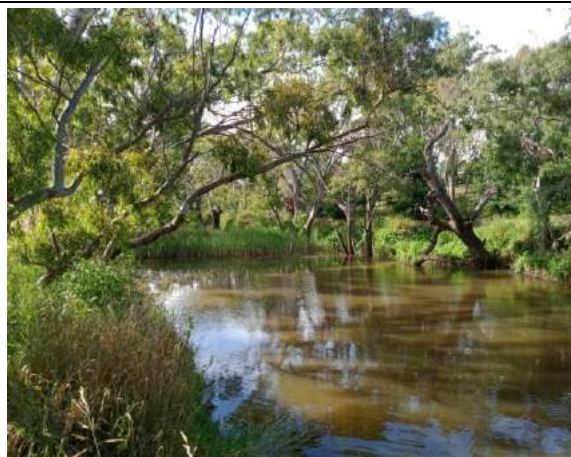
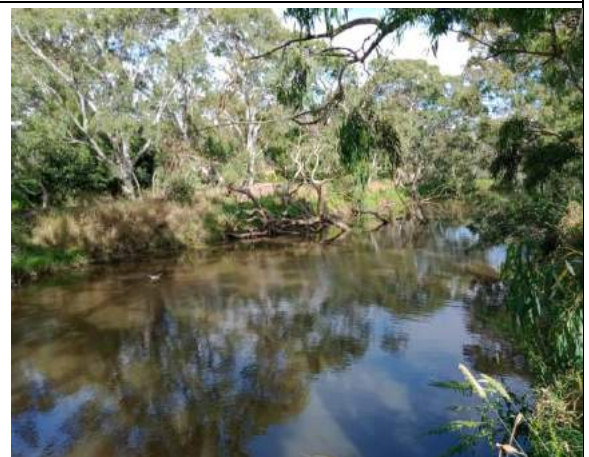
The Barwon River at Winchelsea has large deep pools with a large shallow pool at the top of the reach. The average stream width at this site is twelve meters. The substrate is clay and silt mixed with sand and some gravel. In addition to the *Phragmites* beds at the top of the reach and along some edges there are also patches of *Triglochin*. Large woody debris, trailing grasses and emergent vegetation such as *Polygonum* are also present. Riparian vegetation is predominantly native with many established eucalypts and groundcover is pasture grass. A concurrent snapshot study by EnviroDNA (2019) in Spring found evidence
